Test Report No:	TJ1237	Date:	May 7, 2013
------------------------	---------------	--------------	--------------------

SUBJECT: Flammability Testing to NFPA 286, Standard Methods of Fire Tests for Evaluating Contribution of Wall and Ceiling Interior Finish to Room Fire Growth – 2011 Edition.

PRODUCT EVALUATED: Client refers to samples received as “**AIRLIGHT Building Panels**”. This project was entered into our receiving system on 4/05/13 in good condition.

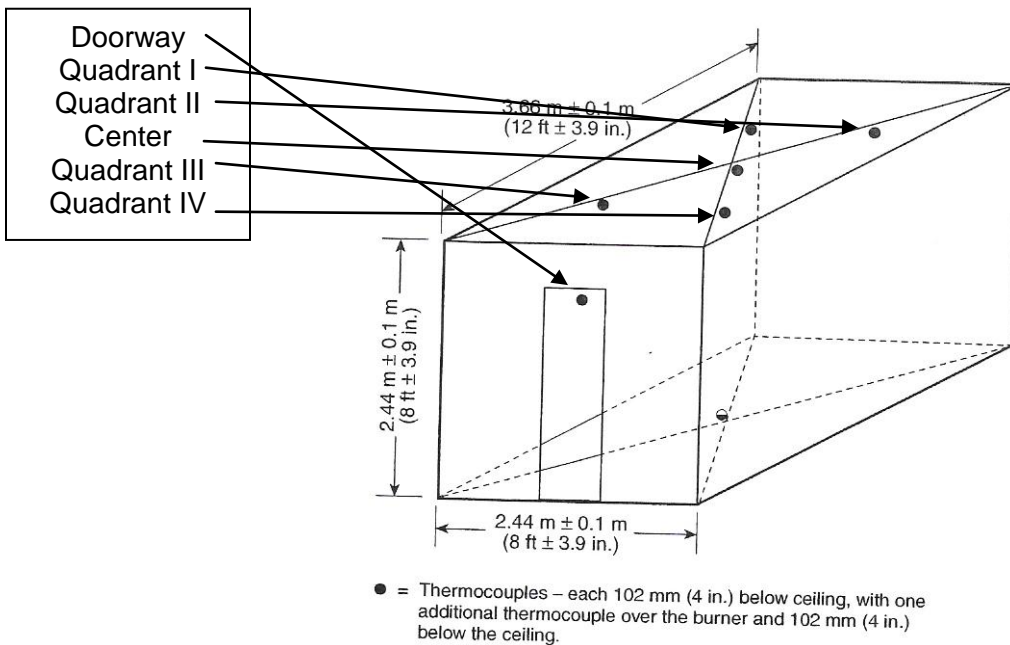
FIGURE 1. Thermocouple Locations

Thermocouple Placement:

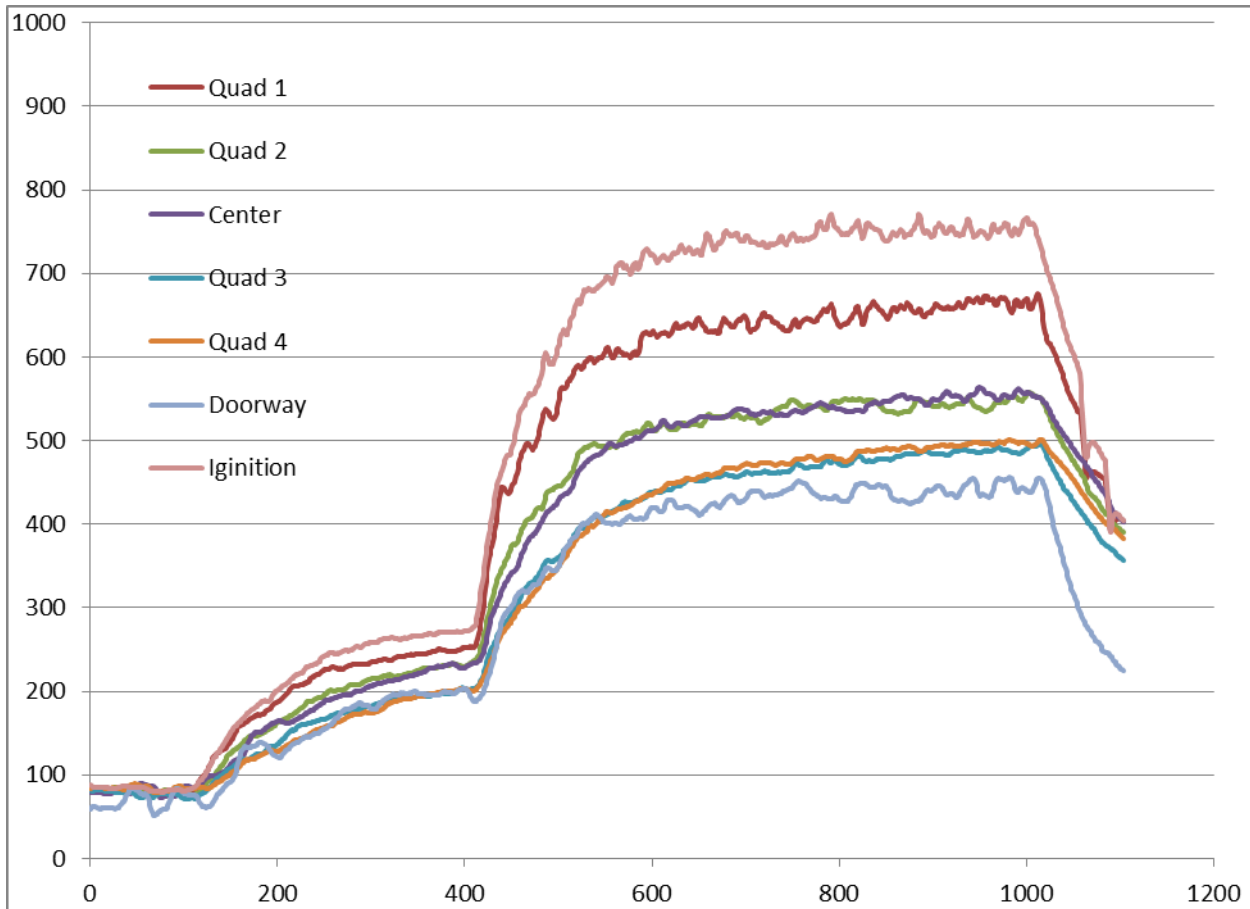
FIGURE 2. Temperature vs. Time

Maximum Peak Temperatures:

Doorway	456°F (236°C)
Center	464°F (296°C)
Quadrant I	675°F (357°C)
Quadrant II	578°F (303°C)
Ignition	772°F (411°C)
Quadrant III	497°F (258°C)
Quadrant IV	502°F (261°C)

AVERAGE UPPER LAYER TEMP – 406°F (208°C)

- Peak Heat Release Rate of 213 kW
- Heat Flux at floor – Peak of 4.4 kW/m²
- Average upper average temperature – 406°F (208°C)
- Flames did not exit doorway
- Both paper targets undamaged during test

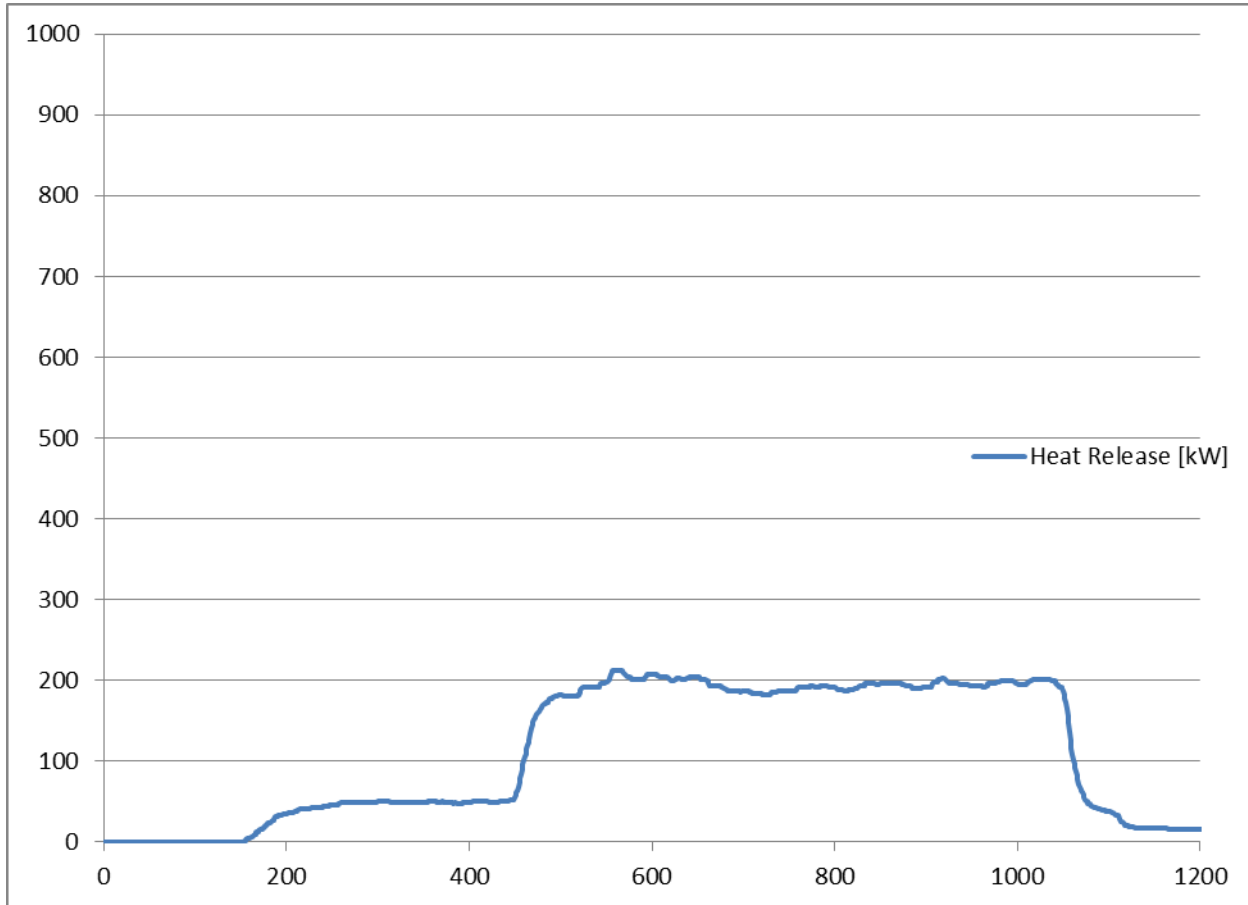
FIGURE 3. Heat Release Rate vs. Time

Numerical Values:

0-5 min average (kW)	47.3
5-15 min average (kW)	192.3
Peak Heat Release Rate	213 kW @ 6:58
Total Heat Released During 15 min Test	124.7

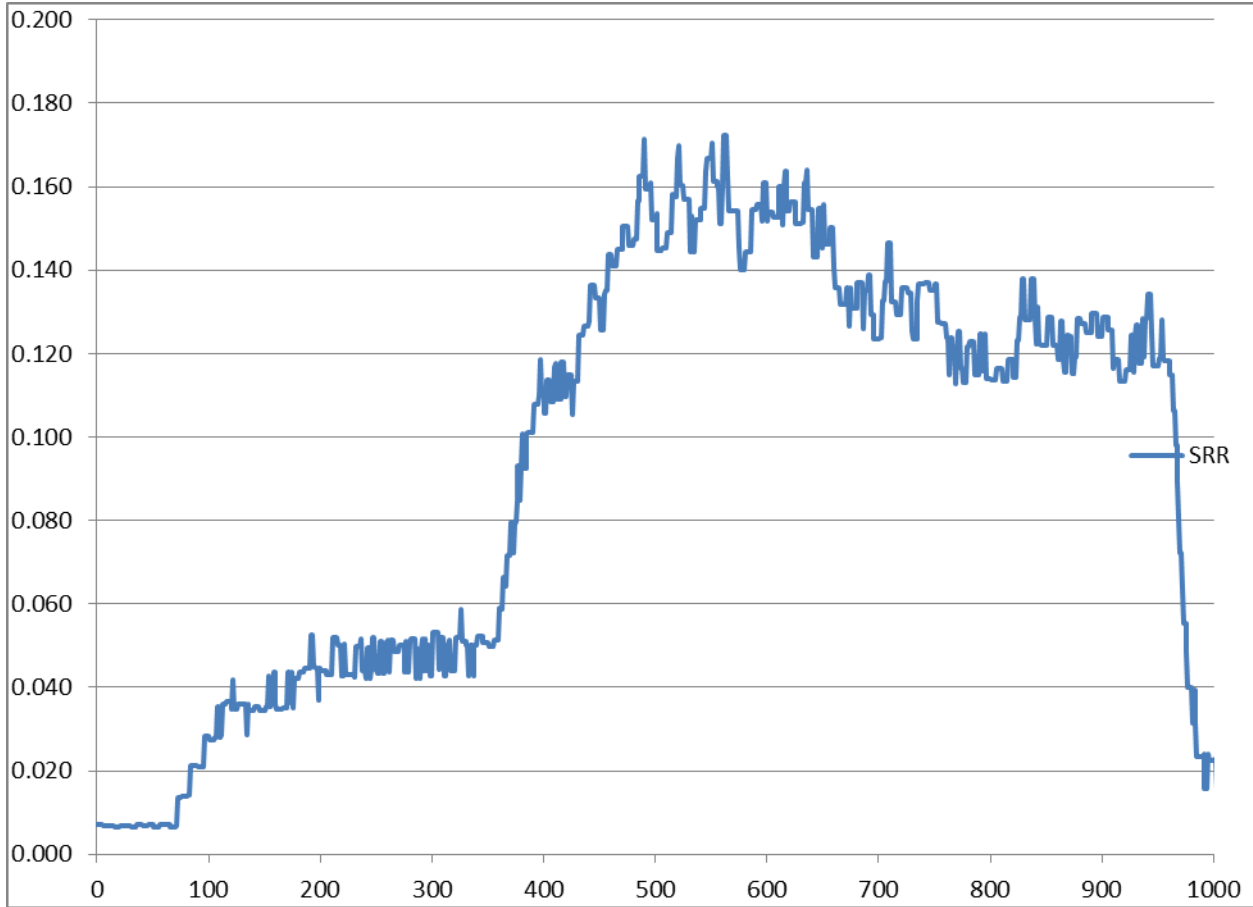
FIGURE 4. Smoke Release Rate vs. Time

Numerical Values:

0-5 min average (m ² /s)	0.05
5-15 min average (m ² /s)	0.13
Peak Smoke Release Rate	0.172 m ² /s @ 7:42
Total Smoke Released	81.7
Peak Obscuration	21%

A peak duct smoke obscuration value of 79% (21 % blocked) and a Peak Smoke Release Rate was 0.172 m²/s 7 minutes and 42 seconds after ignition.

The smoke obscuration reading was taken in the center of a 16 inch diameter duct.

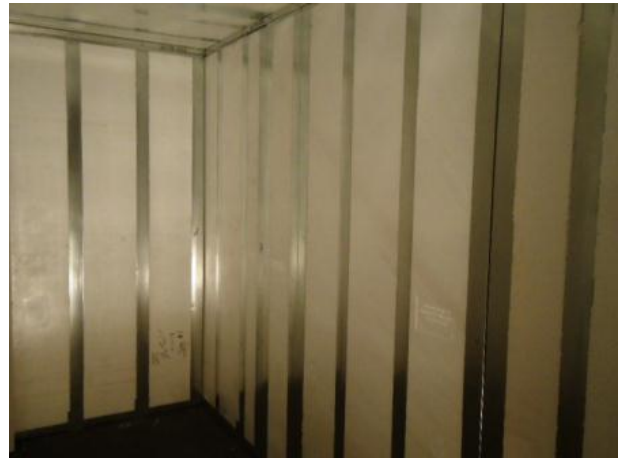
Before Gypsum Board

The test room was built by QAI Laboratories staff in accordance with the recommended practices specified by Wanessa-Sue, Inc. ½" gypsum board was installed onto the walls and ceiling of the test chamber utilizing normal zinc galvanized screws into the metal studs of the wall panel. Metal tape was installed at the joints in lieu of mud and tape. The final interior dimensions were 8 feet high, 8 feet wide and 12 feet deep.

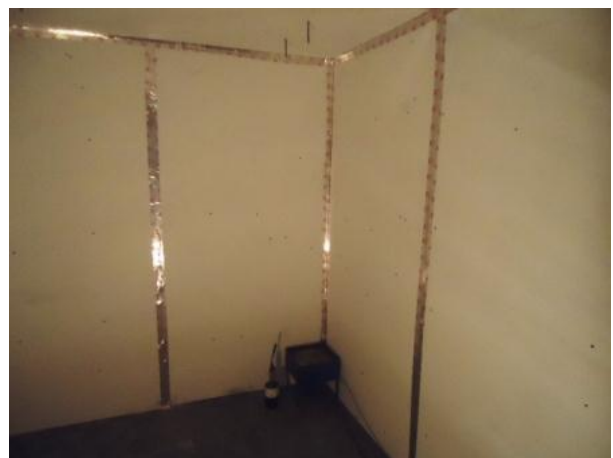
Ignition Corner

The ignition source for the test is a gas burner with a nominal 12 by 12 inch orifice, filled with a minimum 4 inch layer of Ottawa sand. The top surface of the burner through which the gas is applied is positioned 12 inches above the floor. The burner enclosure was placed 1 inch away from each wall in the test corner, opposite the door.

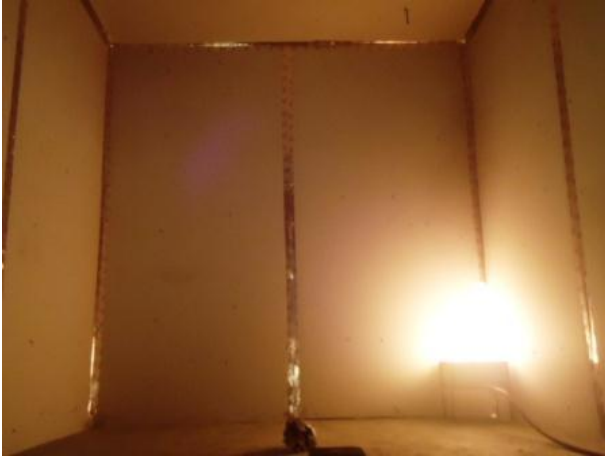
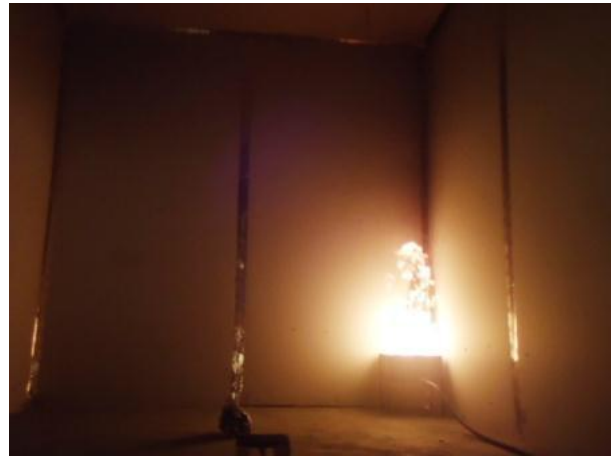
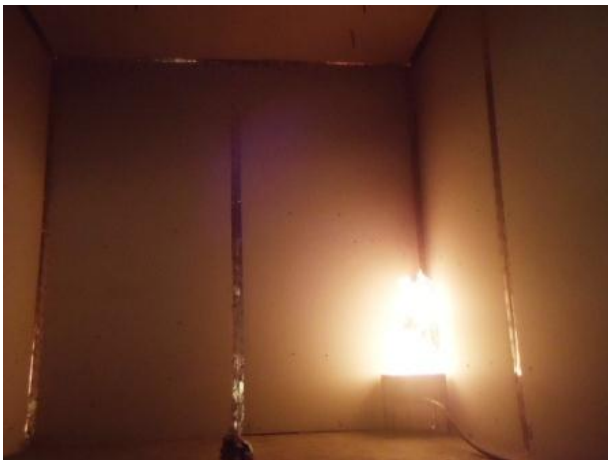
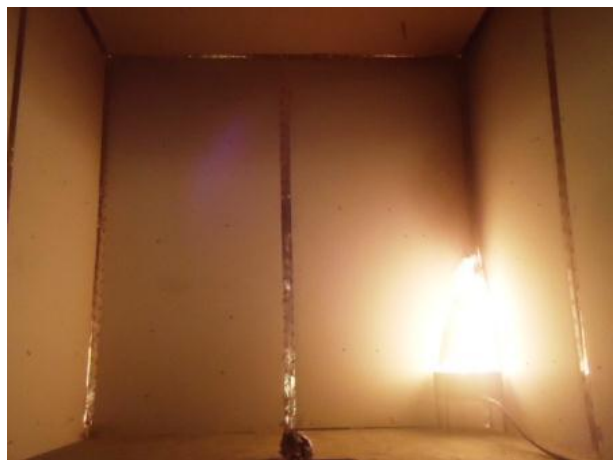
Test Start

2 Minutes In

3 Minutes In

At 5 minutes

- 0:00:00 – Sand diffusion burner lit to 40 kW flame
- 0:01:00 – Very light clear smoke present, some charring on wall directly behind burner
- 0:02:00 – Some small flaming noted in ignition corner and smoke density at steady level
- 0:03:00 – Flame travel up corner of ignition mostly from burner, does not reach ceiling, area of origin charred
- 0:04:00 – Flame level steady, no significant contribution from test assembly noted, light smoke
- 0:05:00 – Sand diffusion burner increased to 160 kW flame
- 0:06:00 – Slight increase in smoke density, smoke light grey in color
- 0:08:00 – No significant flame contribution from the test assembly noted
- 0:10:00 – Smoke is decreasing in density
- 0:13:00 – Little change in above conditions
- 0:15:00 – NFPA 286 test complete, flames immediately self-extinguish after gas shut off

Flame spread of the sample was only minimal and was noted around flame plume of ignition burner. Flames did not reach the ceiling during the first 5 minutes nor did it reach the extremities of the test module and flashover, as defined in the specified test designation, did not occur.

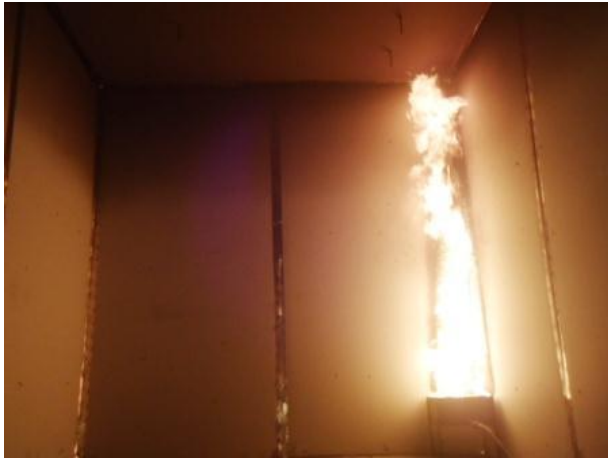
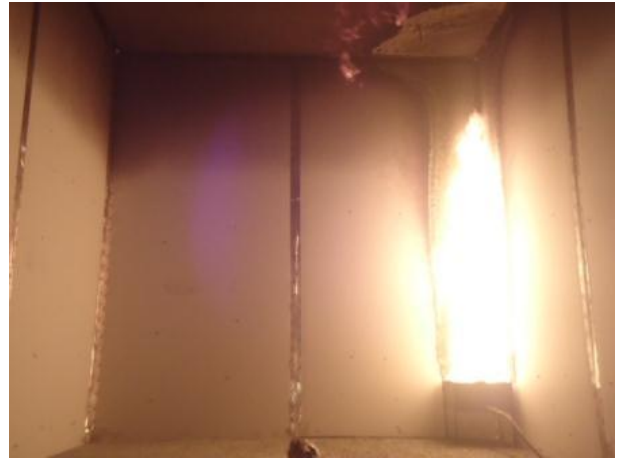
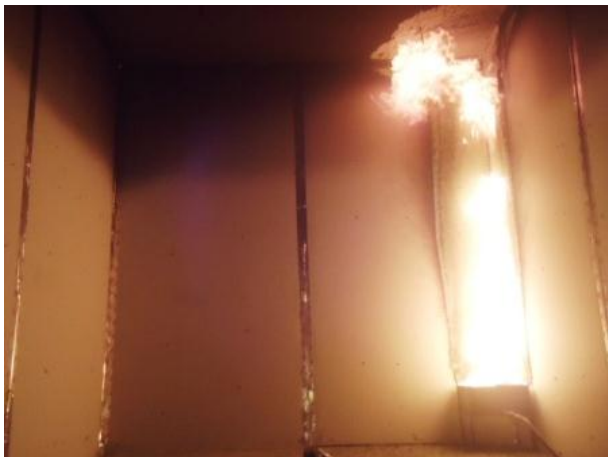
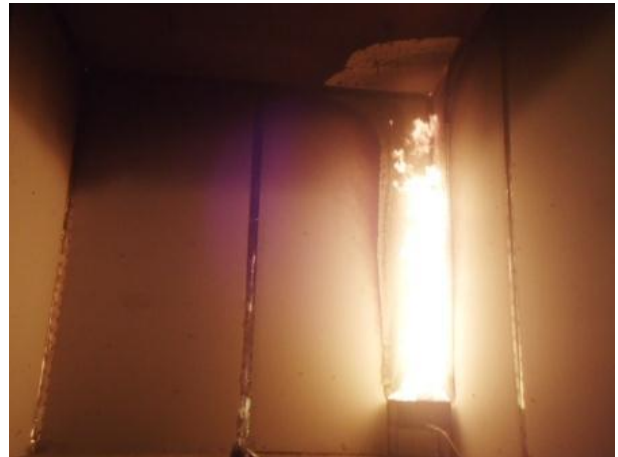
6 Minutes In

9 Minutes In

13 Minutes In

15 Minutes In

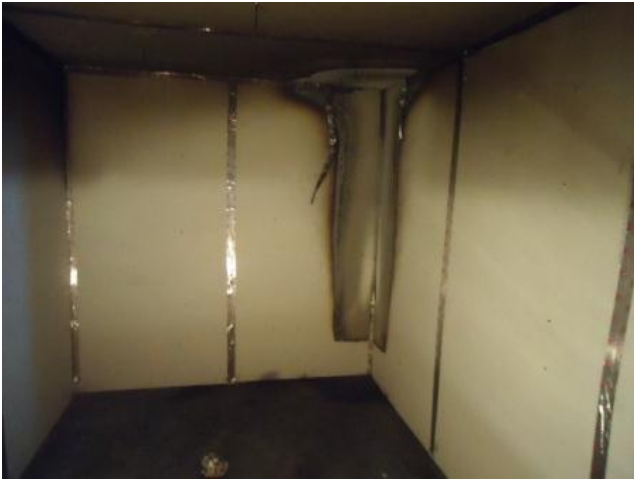
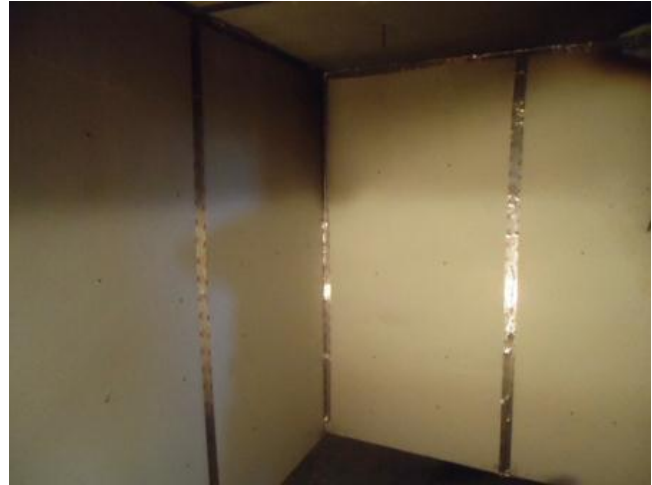
Photos Immediately After Test

All charring as a result of testing this assembly was limited to the corner of the burner placement up the side walls and to the ceiling. Approximately two feet in both directions of the corner of burner placement showed charring up the walls and began to taper out at about 7 feet from the ceiling. The corner of the ceiling at approximately 3 foot radius showed evidence of charring as well. The test of the ceiling showed only dark discoloration due to soot deposition and evidence of slight decomposition of wall surface.

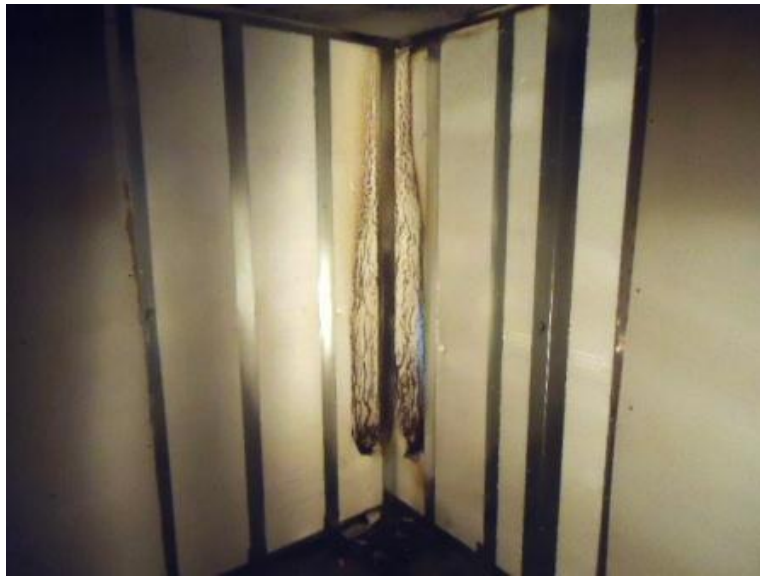
Sample Behind Gypsum Board
